DragonhydeTM

HOOF BATH CONCENTRATE

In-House Laboratory & Field Trial Study Collection

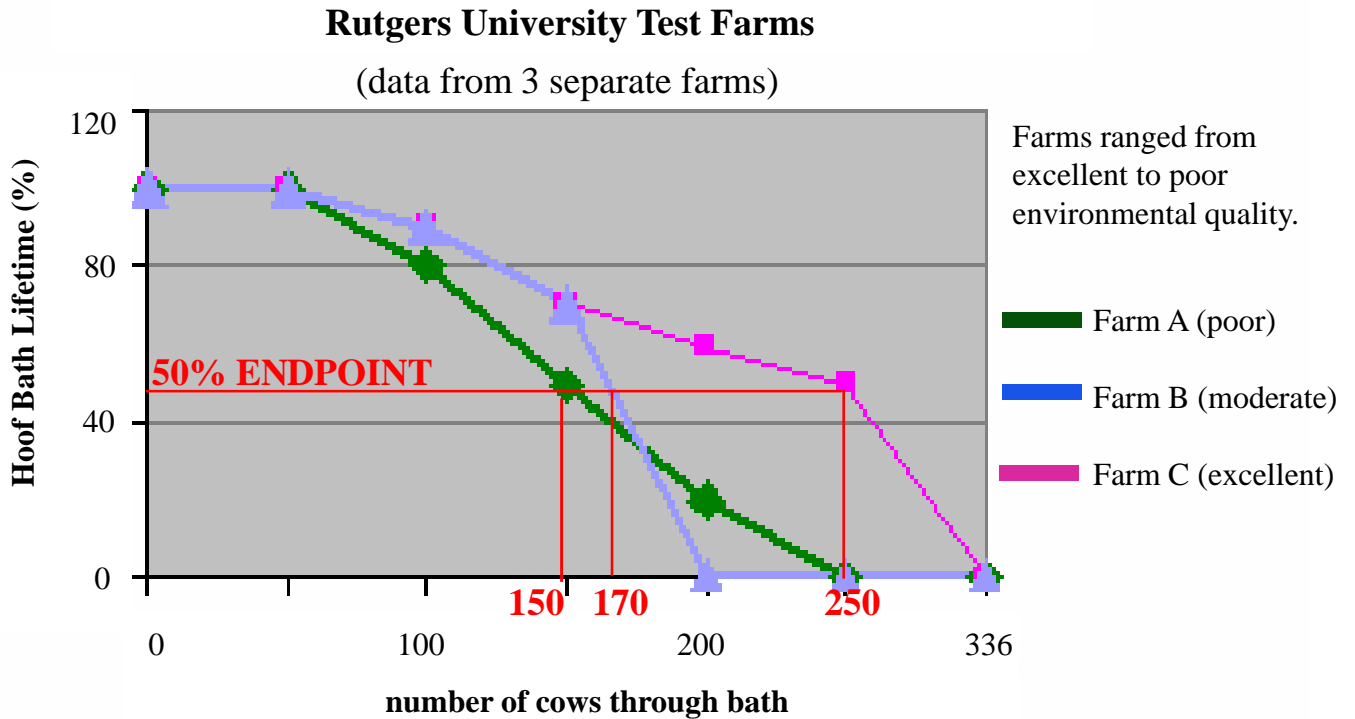
Study #1: Using T-HEXX Dragonhyde HBC With No Pre-Bath

If no pre-bath is used when running T-HEXX Dragonhyde HBC diluted 1:50, an average of 250 cows can walk through the bath before it needs to be discarded.

The main bath of T-HEXX Dragonhyde HBC diluted 1:50, needed to be discarded after 150-250 cows walked through. An assesment of the endpoint at 50% by cleanliness was selected as the recommended change point for comparison.

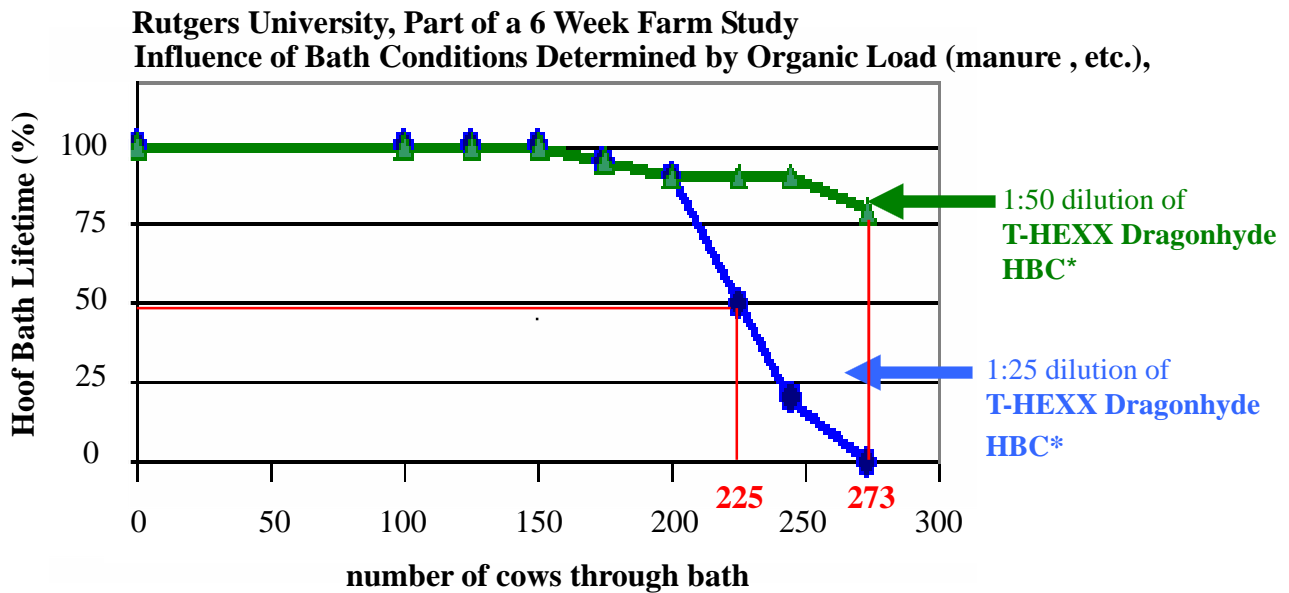
Study #3: Effects of Organic Load in a T-HEXX Dragonhyde HBC Hoof Bath

The conditions, or amount of organic load (manure, etc.) in a hoof bath containing T-HEXX *Dragonhyde* HBC, will determine the number of cows that can walk through the bath before it requires changing.

When the organic load in the bath was high, an average of 225 cows were able to walk through a single bath made up of T-HEXX *Dragonhyde* HBC before it required changing. This bath contained a 1:25 dilution made of 2 parts T-HEXX *Dragonhyde* HBC plus 48 parts water.

When the bath had less organic load, the studies implies more than 300 cows were able to walk through a single bath made up of T-HEXX *Dragonhyde* HBC before it required changing. This bath contained a 1:50 dilution made of 1 part T-HEXX *Dragonhyde* HBC plus 49 parts water.

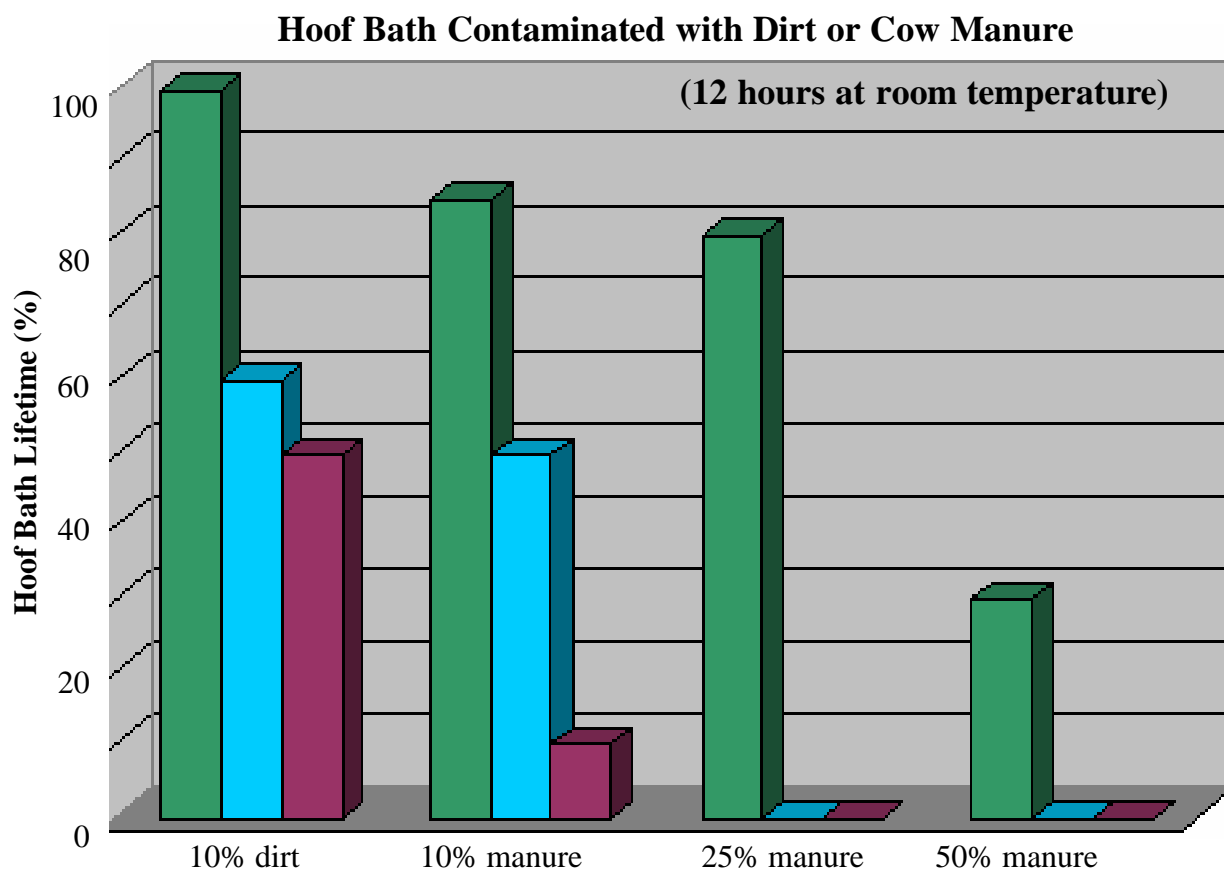
Study #4: Organic Load

An in-house laboratory test demonstrated, when the organic load in the main bath became high, changing of the bath at a lower number of cows would be necessary.

T-HEXX Dragonhyde HBC (diluted 1:50) was able to work efficiently in the presence of a much higher organic load than its leading competitors.

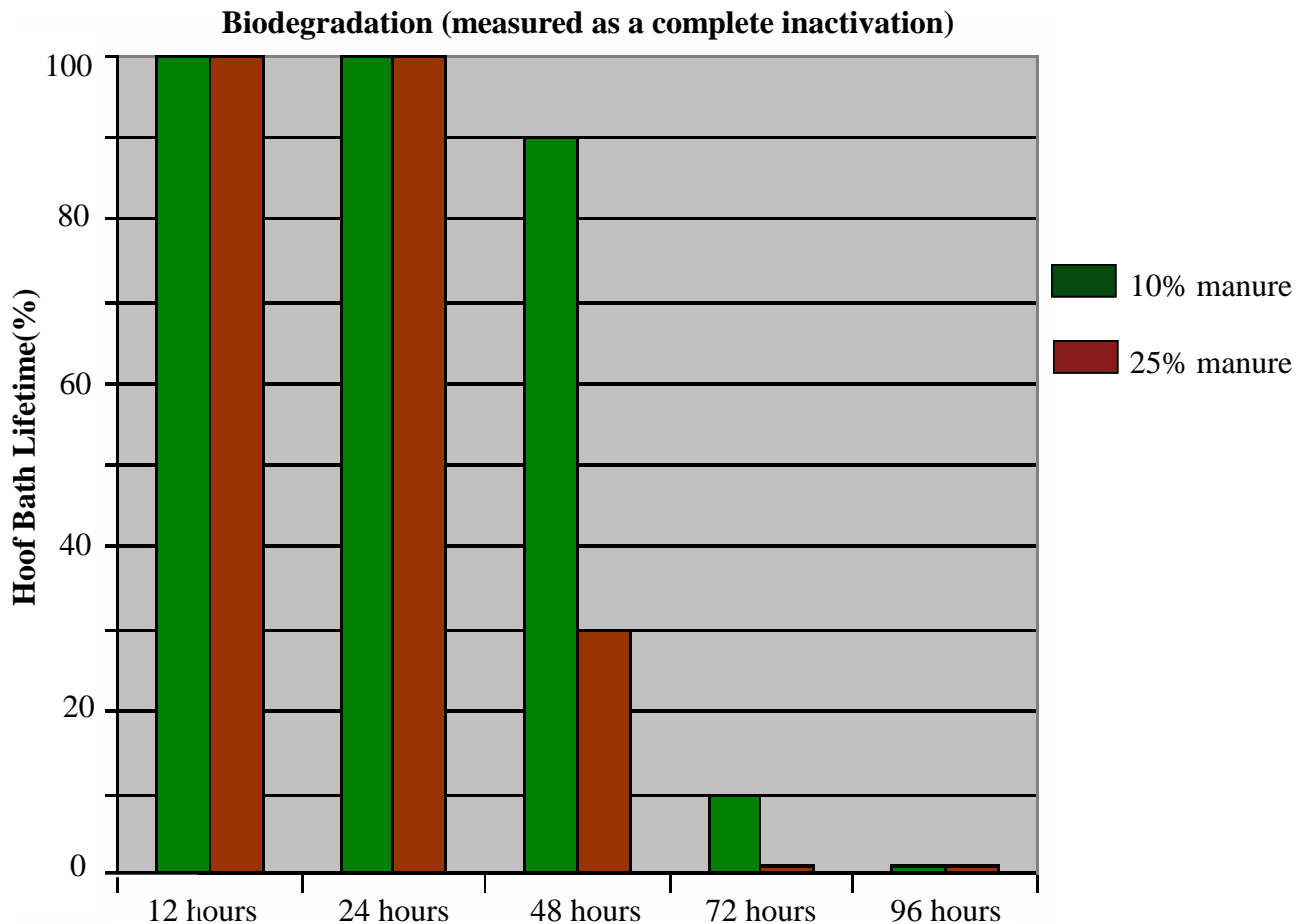
Study #5: Biodegradation by Manure

An in-house study was conducted to assess the loss of T-HEXX *Dragonhyde* HBC (diluted 1:50) functionality when contaminated with manure vs. time.

Complete biodegradation (measured as complete loss of functionality) of T-HEXX *Dragonhyde* HBC (diluted 1:50) occurred after 4 days of being incubated with 10% to 25% manure at room temperature. T-HEXX *Dragonhyde* HBC (diluted 1:50) contaminated with 25% manure resulted in a loss of greater than 50% of its functionality within 48 hours.
